Case Study

**Not all superheroes
wear capes
- some wear overalls**

How CPM reduced downtime from 16 weeks to 72 hours and saved our manufacturing client a fortune

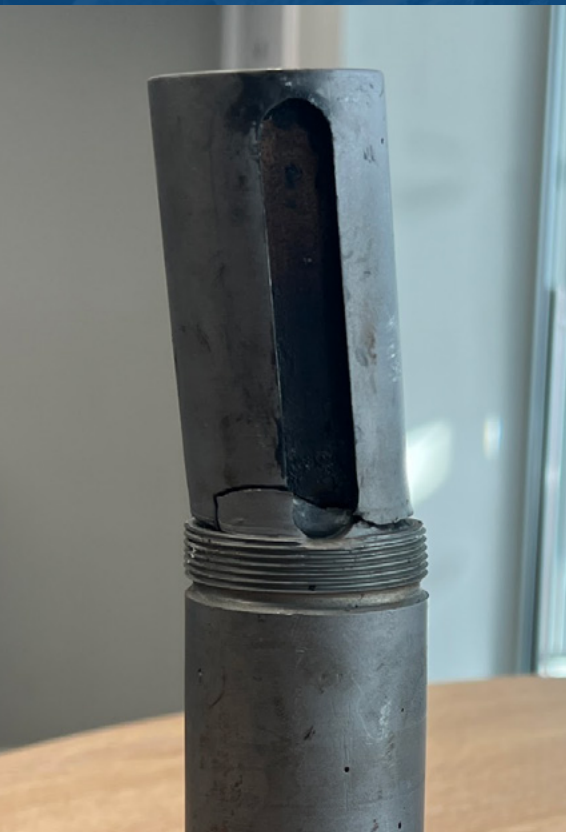
Within 4 hours of our customer's initial call, not only were we able to tell them that the damage had been caused by a combination of a previous repair and operational issues at the clients site. We were able to report back on its exact nature.

The diagnosis:

- Gearbox shaft- snapped
- Attachment sprocket - damaged
- Gearbox bearings - worn
- Motor windings - contaminated
- Feedback signal amplitude - low
- Motor bearing - worn

With the original gearbox shaft damaged beyond reliable repair, we brought in a specialist CNC manufacturing partner to build a replacement shaft.

While they were working on that, CPM engineers worked hard to repair the motor which included:

- Cleaning and changing bearings and seals
- Refurbishing feedback unit
- Aligning and setting up feedback to OEM specs
- Assembling the motor to OEM specs
- Setting up and testing the motor
